# BELZONA SEALS OIL LEAKS ON TRANSFORMER BUSHINGS

ID: 4310

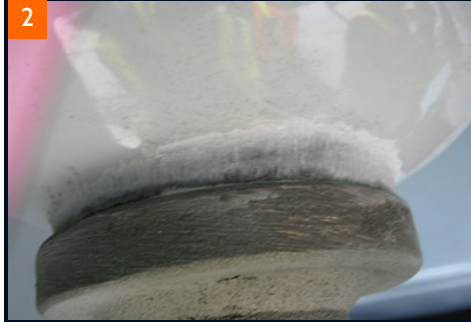
It was noted that a small oil leak was present at the bushing. No oil should leak from this bushing. The heavy electrical cables were not supported adequately.

1. Transformer bushings
2. Ceramic insulator after abrading with Dremel and cleaning
3. Ceramic insulator and bushing masked off
4. Application completed

Application was carried out in accordance with Belzona Know-How System Leaflet VPF-11. The ceramic insulator was roughened with a Dremel before applying the Belzona 1161 by brush to seal the oil leaks.
