# BELZONA SAVES AUTO INDUSTRY A CHUNK OF CASH

ID: 432

Worn cylinders - welding robot control

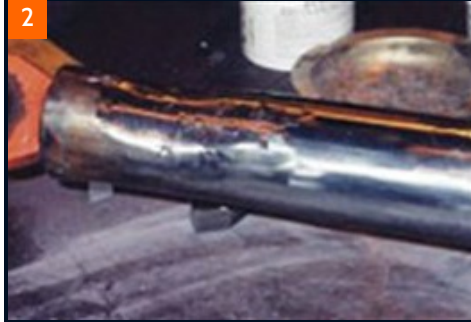
1. Equipment - welding robot
2. Worn cylinder
3. Almost there
4. Completed job

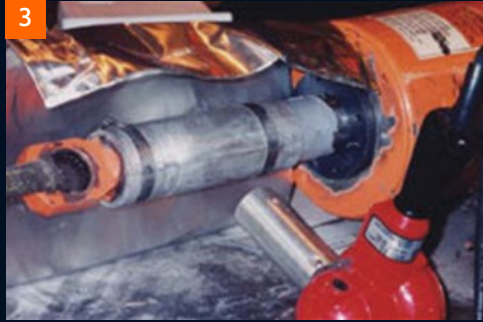
Worn shaft

Welding robot control cylinder is simply a spring loaded shaft inside a housing. It controls the movement of the welder to and from the work - (slow going in, very quick return). Once the cylinders became worn, like the one in the photo, the whole assembly was replaced at a cost of \$3,500. The Belzona in-situ repair cost less than 5% of the replacement. There are 400 welders in the production line with two cylinders each.

Application was carried out in accordance with Belzona Know-How System Leaflet MPT-2.
