# BELZONA EXPANSION JOINT SYSTEM FOR BUSY BRIDGE

Bridge spanning the Intracoastal Waterway - Broward County, Florida

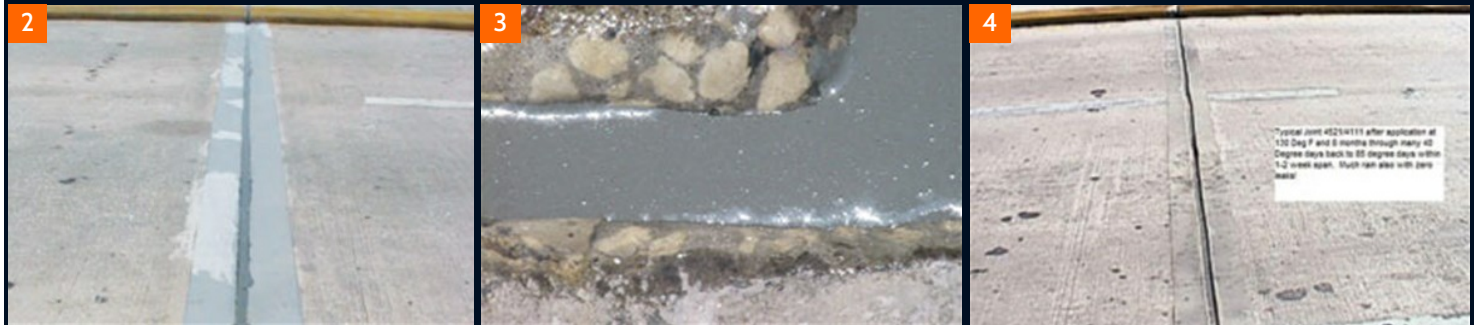
## PHOTOS

Inferior products together with heavy traffic caused expansion joints to fail. This allowed salts from the atmosphere and water to ingress to steel areas underneath the roadway which began to suffer from corrosion.

1. Joint prepared for nosing and seal
2. Completed Belzona system
3. Close look at seal
4. One year of service - without blemish

Application was carried out in accordance with Belzona Know-How System Leaflets FPA-5 and FPA-6.

Belzona® 4521 shares the same chemical properties as other Belzona® 4000 Series Magma Products. This means that no additional conditioners or interim preparation steps are required. This "wet to wet" application forges an intimate, durable bond, and saves significant application time.
