# BELZONA PROTECTS PASSENGER FERRY JET TUBES

ID: 4343

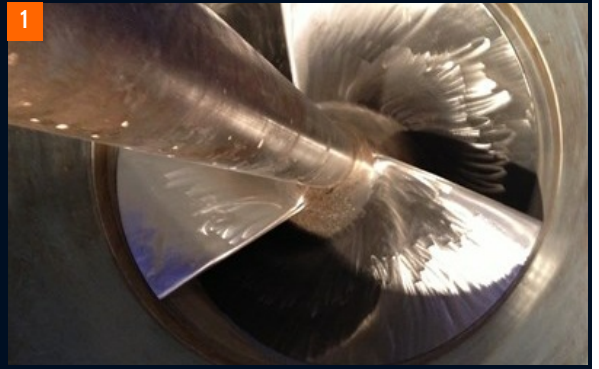
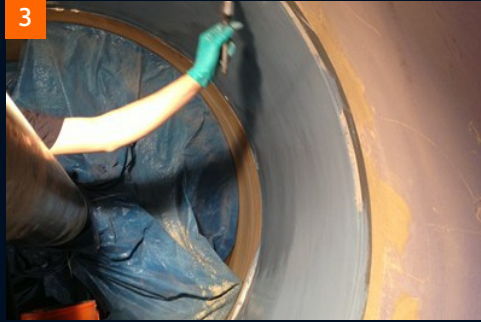
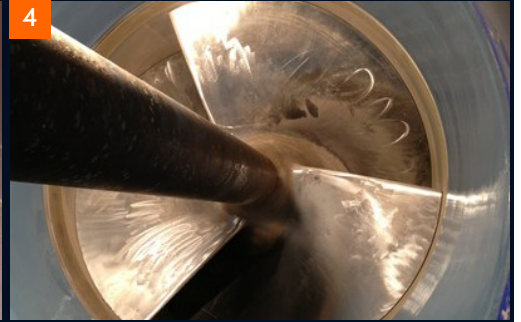
Existing Belzona 1341 still in good condition Flash blast over existing Belzona 1341 Top hat sections rebuilt with Belzona 1111 Belzona 1341 applied to complete the application

Application is carried out in accordance with Belzona Know-How System Leaflets SOS-1 & 2. After removing and replacing "top hat" inspection covers, Belzona 1111 applied to fair off before coating entire tube with Belzona 1341.

The application is an annual job that is performed while the ferry is in dry dock. Although most of the Belzona 1341 is intact, by applying an extra coat of Belzona 1341 over the existing Belzona coating the jet tubes are kept in full working service rather than waiting until a major failure.
