# BELZONA REBUILDS MARINE DIESEL ENGINE BLOCK

ID: 4344

Caterpillar diesel engine on passenger ferry.

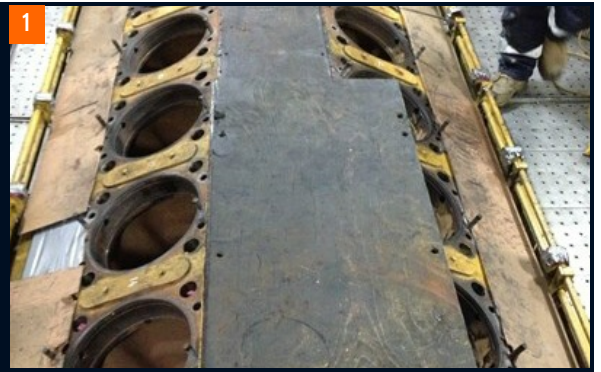
Cylinders from the port outer main engine were suffering from severe cavitation beyond the original Belzona repair. Belzona has been routinely used to repair these areas for over 10 years.

1. General view of the engine Cavitation damage around the existing Belzona 1311
2. Area ground out to depth of 3mm
3. Blasted area in preparation for coating with Belzona 1391
4. Completed Belzona 1311 repair
