# BELZONA PROTECTS SLOP OIL TANK

ID: 4354

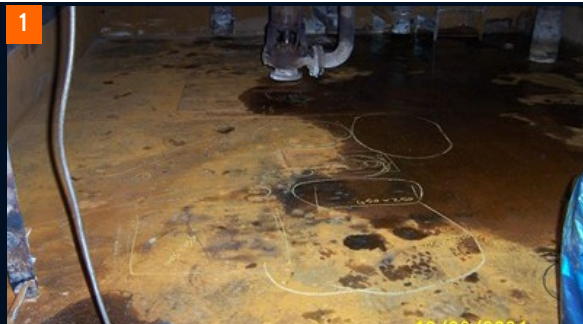
Severe corrosion of the tank base due to the chemicals, oil and heat involved led to pitting and holing of the tank base resulting in loss of containment.

1. Tank as inspected in 2004
2. Tank base following plate welding
3. Initial application completed in 2004
4. Belzona coating as inspected in 2012

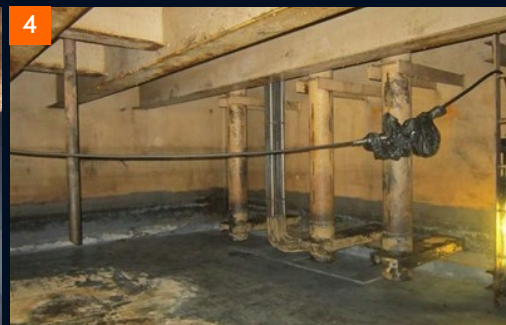
The cocktail of hot aggressive chemicals and oil residue was causing aggressive pitting and corrosion of the existing carbon steel plates. Following inspection in 2012, the lining was found to be in excellent condition requiring only minor remedial repairs. The coating had ensured the tank experienced trouble free service for 8 years.
