# BELZONA EXTENDS THE LIFE OF SWIMMING POOL FILTERS

ID: 4356

Filter units for a swimming pool.

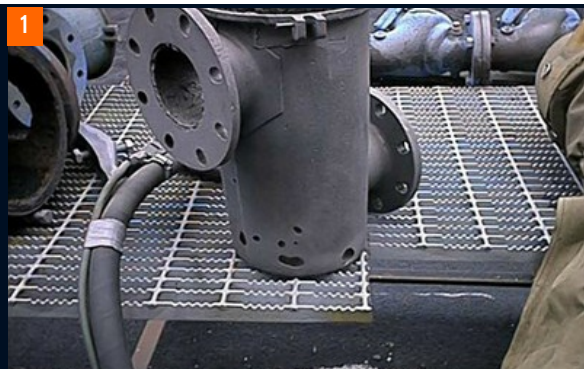
The filter pots had corroded through in various places. Due to the age of the unit direct replacement not available so replacement of the filter with a new unit would be both expensive and complicated, requiring re-design of pipework.

1. Condition of unit after blasting showing holes in bottom
2. Eroded sealing flange
3. Rebuilt unit coated with Belzona 1321 on the inside and Belzona 5811 on the outside. Note reformed sealing flange face.

Application was carried out in accordance with Belzona Know-How Leaflets VPF-1 and VPF-2. Plates were bonded over holes and faired with Belzona 1311 before internal surfaces were protected with Belzona 1321 and externals with Belzona 5811. Sealing faces were also modified to improve seal.
