# SF6 GAS LEAKS SEALED WITH BELZONA

ID: 4357

Gas insulated electrical switchgear

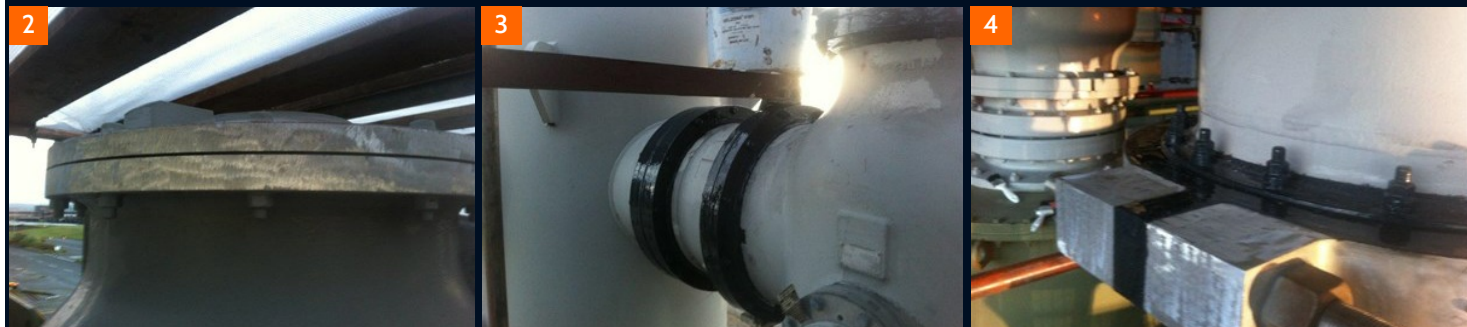
Failure of the original sealant between the bolted flanges had resulted in loss of containment of the insulating SF6 gas, a potent greenhouse gas.

- Bolted joints prior to application
- Surface Preparation carried out using a disc grinder and solvent cleaning
- Joints sealed with Belzona 2221 coating
- Bolts were also encapsulated, completely stopping leakage of SF6 gas in all accessible areas

Application was carried out using a modified version of Belzona System Leaflet TCC-1. The equipment operator lowered the pressure inside the equipment prior to the application. The area was thoroughly cleaned and roughened before the flange and bolts were completely encapsulated with the Belzona® 2221 focusing on the gap between the bolted faces. Once cured, the equipment was re-pressurized and tested for leaks.
