# NON-SLIP SAFETY SYSTEM IN HOSPITAL DISH WASHING ROOM

ID: 436

Inferior non-slip safety system

Hospital dish washing room floor

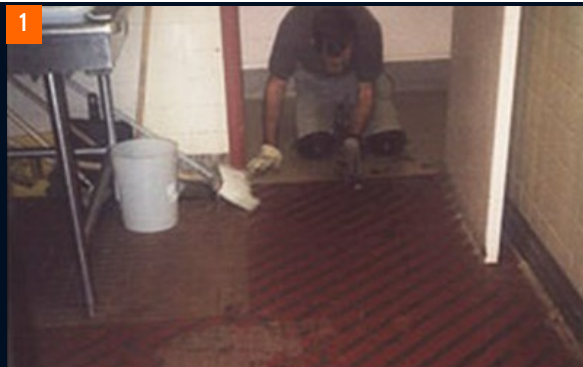
Customer had contracted with another vendor to apply a non-slip safety system to the dish wash room floor. However, soon after completion of the application, it was found that the surface was extremely slippery. Belzona was approached to apply our standard system over this coating. Within a few months the inferior coating started to delaminate. We were contracted to remove all the red coating and apply a Belzona safety grip system directly to the original floor tiles. Photograph shows removal in progress.

1. Previous failed system being stripped from the floor
2. View of application
3. View of another section of the application
