# BELZONA REPAIR EROSION/CORROSION DAMAGE TO ABSORBER

ID: 4361

Carbon Steel Bubbler Hood

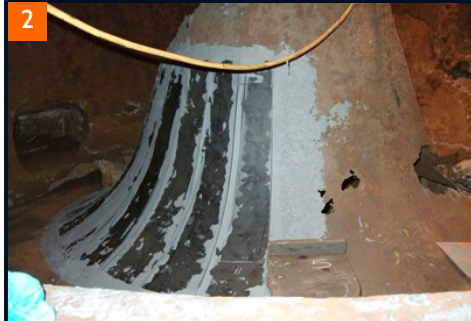
Extensive damage to equipment caused by erosion corrosion issues.

1. Bubbler Hood post blasting
2. Bonding of plates using Belzona 1121
3. Bonding of new dome piece
4. Overcoating of application using Belzona 1391

This application was carried out with a modified version of Belzona Know-How System Leaflet TCC-5. After surface preparation was completed by grit blasting Belzona 1121 was used utilising its extended working life to bond the large contoured plates to damaged area then Belzona 1391 was applied to give maximum protection to process conditions.
