# BELZONA PROTECTS DAMAGED BOOSTER FAN

ID: 4363

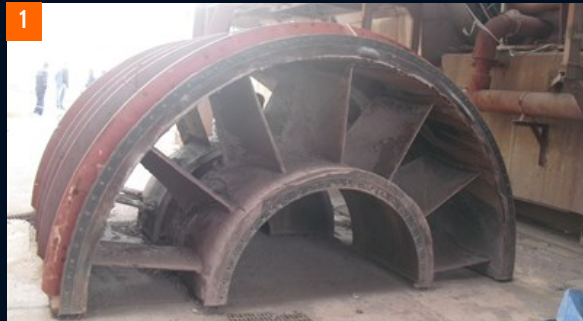
General and pitting corrosion occurring across the fan housing and diffuser. Pitting was filled and then whole area was coated with Belzona high temperature coatings.

The booster fan from an electric powerplant had damage on the case around the diffuser and the fan housings. Damage caused by high temperatures and corrosion. Previous BIRR coating failed.

1. Damaged booster fan.
2. Pitting damage and blasted substrate.
3. Application of Belzona 1391T.
4. Finished application.
