# BELZONA PROVEN SOLUTION FOR CONDENSER MAINTENANCE

ID: 4364

CCGT Power Station, North Wales, UK

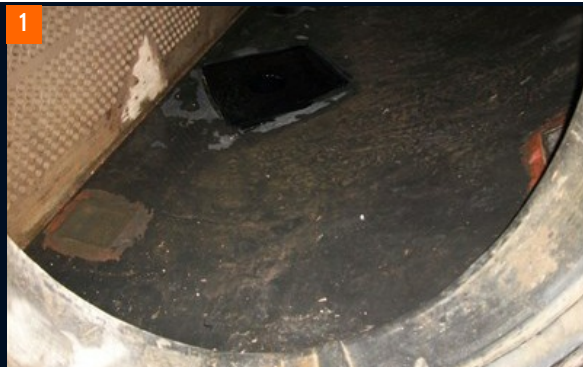
1. Internal lining repairs
2. One of the corroded drain pipes
3. Split collar being bonded to vent pipe using Belzona 1161
4. Completed repair to vent pipe after coating with Belzona 5831

Application was carried out in accordance with Belzona system Leaflets HEX-3, 4 & 9. At areas of high cavitation, Belzona 2141 was used as a patch repair to the internal lining. Collars (curved plates) were formed and bonded with Belzona® 1161 to the vent and drain pipes. The repair area was then over coated with Belzona® 5831 to reinforce the repair and to protect against further corrosion.

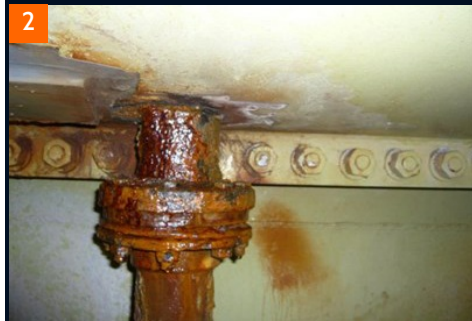
Condenser water boxes at a Combined Cycle Gas Turbine (CCGT) power station. Annually over the past 5 years Belzona® 2141 has been successfully used to carry out repairs to the internal lining. In 2012 engineers at the power station identified severe corrosion at the external vents and drain pipes which was resulting in leakage.
