# LARGE NON-SLIP SAFETY SYSTEM APPLICATION

ID: 437

## PROBLEM

## APPLICATION SITUATION

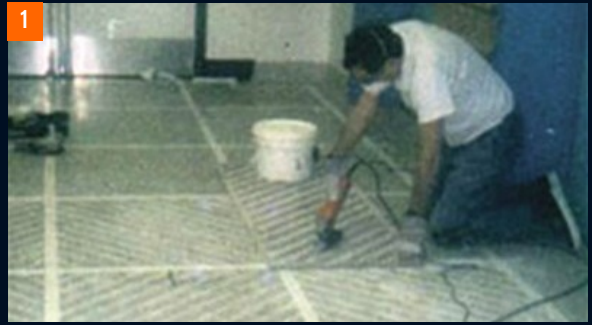
1. Preparation underway using a special silicon carbide grinding tool and template
2. Hospital opted for various different 'chevron' style patterns to help break up the areas
3. Another view of application with a different pattern
