# NON-SLIP SAFETY SYSTEM SUPERIOR TO SAFETY 'STRIPS'

ID: 438

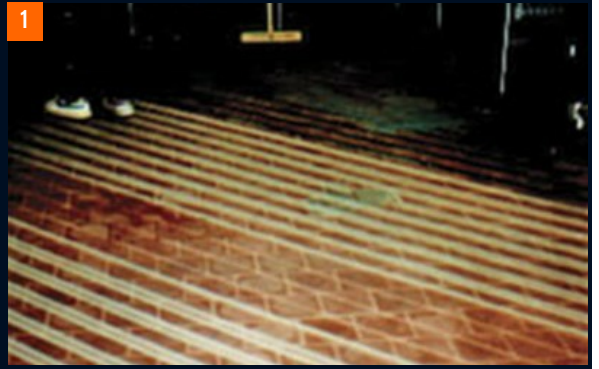
1. Preparation underway using a straight edge template and a saw fitted with a double half inch masonry cutting blade and vacuum. This involved a double pass to achieve the desired 1-inch prepared strip. Masking tape was applied to the edges.
2. Completed application.

Application was carried out in accordance with Belzona Know-How System Leaflet FPA-8.
