# BELZONA PROTECTS OFFSHORE CONDUCTOR CABLE

ID: 4382

Clamps for securing conductor cable to platform leg.

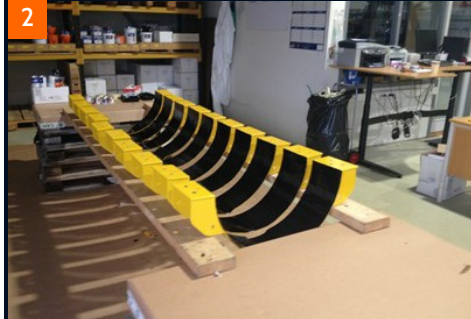
1. First stack of clamps ready for application
2. Belzona 2141 applied
3. Splash zone clamps assembled
4. Underwater clamp assembly in place

Application was carried out using a modified version of Belzona System Leaflet SHM-9. Internal areas of clamps were lined with 1mm of Belzona® 2141. An approved paint was applied to exteriors.
