# BELZONA MAINTAINS POWER PLANT MAIN COOLING WATER SYSTEM

ID: 4385

Large water pumps with concrete volutes circulating the cooling water for the Power Station

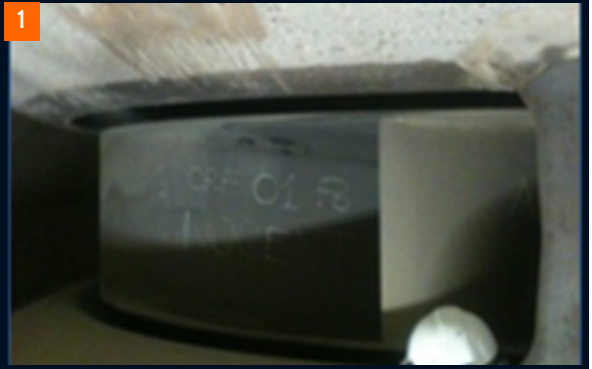
The continuous flow of water through the system had caused the concrete construction to wear both upstream and downstream of the pump, as well as inside the pump volute. This erosive wear had led to micro cracking of the concrete. In addition the rough concrete surface had led to a loss of efficiency as the worn concrete walls created a more turbulent flow.

1. Volute prior to application
2. Application of Belzona 4111 completed
3. Application of Belzona 1341
4. View of the volute following repair
