# DISH WASHING ROOM - SAFER WITH BELZONA SYSTEM

ID: 439

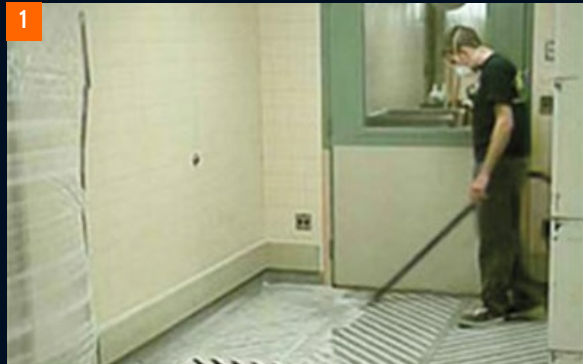
1. Preparation underway using a special silicon carbide grinding tool and template
2. Hospital opted for various different 'chevron' style patterns to help break up the areas
3. Another view of application with a different pattern
