# BELZONA LAP JOINT REPAIR AT SAWMILL

ID: 44

Conveyor belt that transfers pieces of veneer to the chipper.

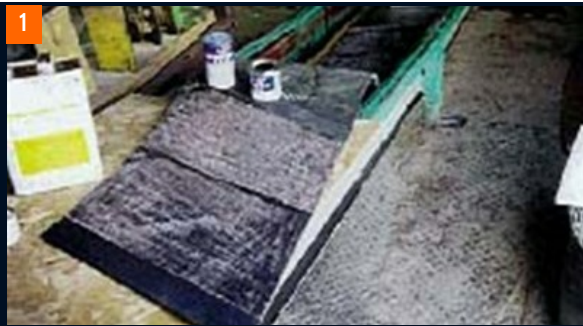
Fine pieces of veneer and moisture contributed to joint deterioration and failure within a matter of a few weeks.

1. Delaminated lap joint being prepared for the Belzona application
2. Both halves of the belt were coated with Belzona 2111
3. The lap joint bonded together for a long lasting, durable, in-place repair

The application was carried out in accordance with Belzona Know-How Leaflet SHM-3.
