# WET FLOORS MADE SAFE WITH BELZONA

ID: 440

Hospital - Victoria, British Columbia, Canada

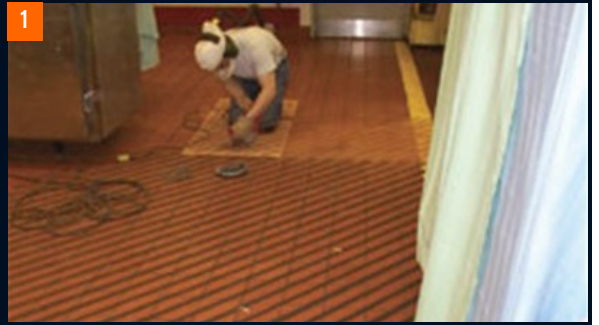
1. Preparation underway using special silicon carbide grinding tool and template
2. Masking completed and application of grip system in progress
3. View of completed section of food prep area
4. View of completed wash area

Application was carried out in accordance with Belzona Know-How System Leaflet FPA-8.
