# BELZONA 1521 PROTECTS HYDROCYCLONE

ID: 441

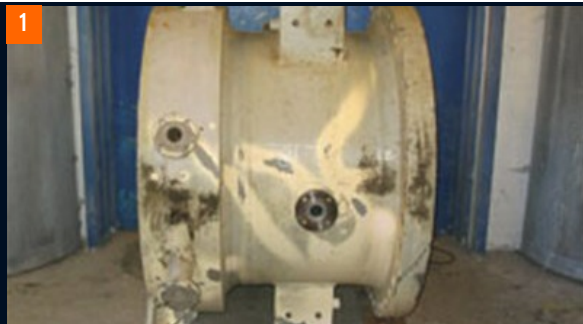
Failure of the existing glass flake lining had led to corrosion of the hydrocyclone body, which operates at elevated temperature.

1. Hydrocyclone body
2. Application of Belzona 1521 in progress
3. Completed application
