# BELZONA 1521 PROTECTS OIL/GAS/WATER SEPARATOR

ID: 442

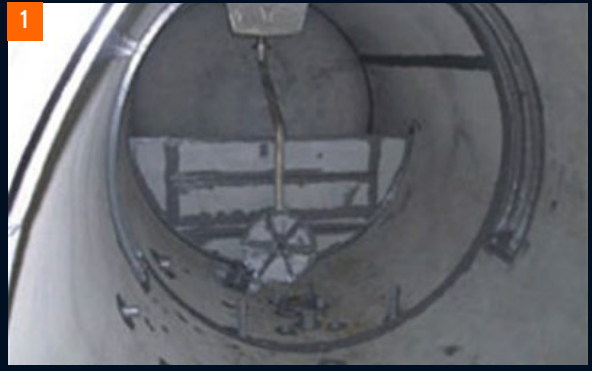
1. Stripe coating of welds, nozzles and brackets
2. Completed upper half of vessel
3. Completed weir area and brackets

Following grit blasting, stripe coating was completed using Belzona® 1391 for all nozzles, welds and brackets. Following reblasting Belzona® 1521 was applied using heated airless spray.
