# LEAKY ROOF IS NO PROBLEM FOR BELZONA

ID: 443

Factory roof - Texas U.S.A.

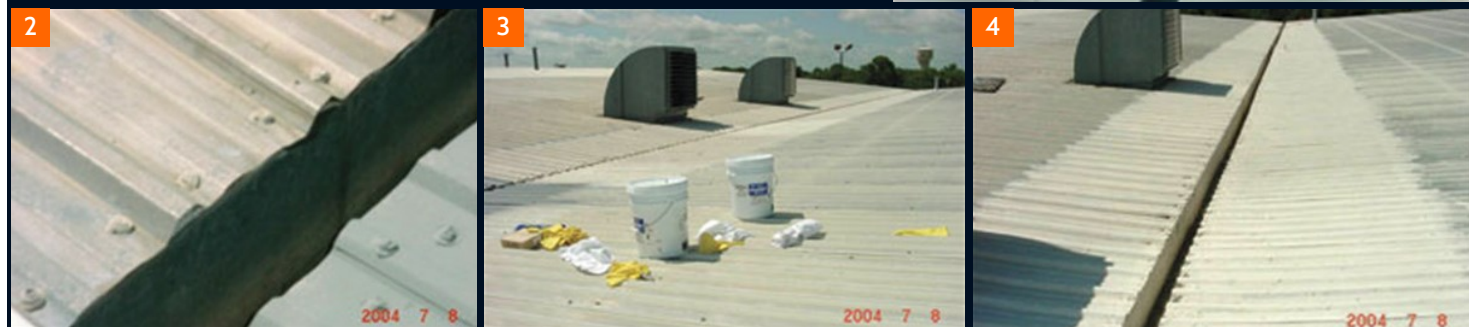
Galvanized roof had numerous leaks around gutters. Previous attempts to stop leaks with conventional roofing materials failed.

1. Conditioned and coated
2. Roof gutters
3. View of roof area
4. Another view of the gutters

Areas were cleaned, conditioned and two coats of Belzona® 3111 were brushed on. The total area protected with Belzona® 3111 was 8,000 sq. ft.
