# BELZONA REPAIR AND PROTECTION OF REFRIGERATION UNIT

ID: 444

End covers and tube sheet of a chiller unit from the hotel's air conditioning plant.

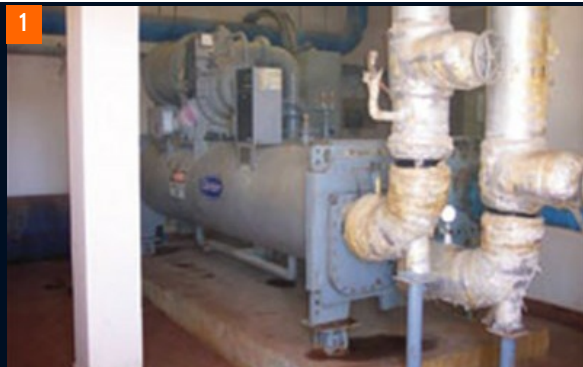
1. General view of the refrigeration unit
2. The corroded tube sheet
3. The degree of erosion clearly evident after surface preparation
4. Completed application

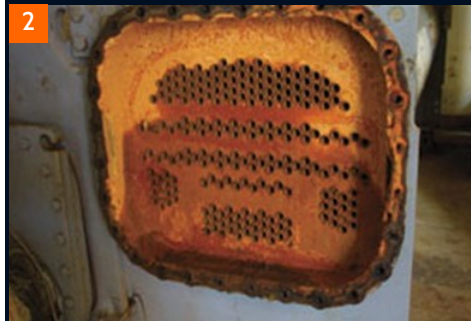
Erosion-corrosion on all water side components. Particularly deep erosion on tube sheet around the tubes.

Eroded metal rebuilt with Belzona® 1311 before all surfaces were protected with two coats of Belzona® 1321. Long term repair and protection given insitu, with minimum disruption to plant operation.
