# BELZONA ROUTINE CYLINDER SALVAGE OF ENGINE BLOCK

ID: 445

Diesel engine block from large river cruise ship

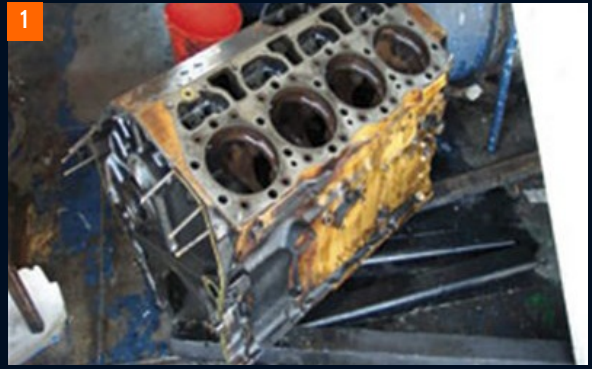
1. The engine block
2. Location of damage
3. Close up of the cavitation
4. Completed application

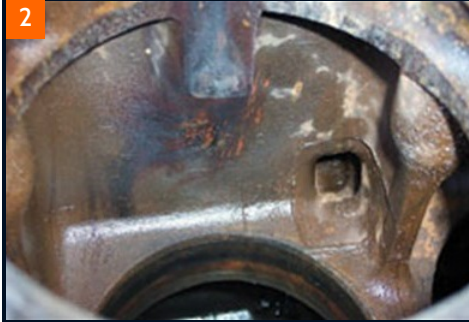
Cavitation damage in water jacket

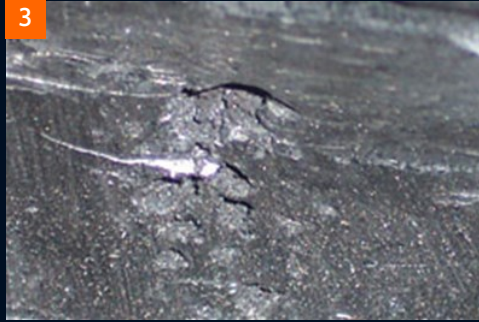
This is a routine repair on engine blocks as cavitation is a common problem in this area of the engine. Belzona provides a quick effective repair without heat and provides good cavitation resistance in the hot coolant.
