# BELZONA REPAIR TO SHAFT AND KEYWAY OF DIESEL ENGINE TEST DYNAMOMETER

ID: 446

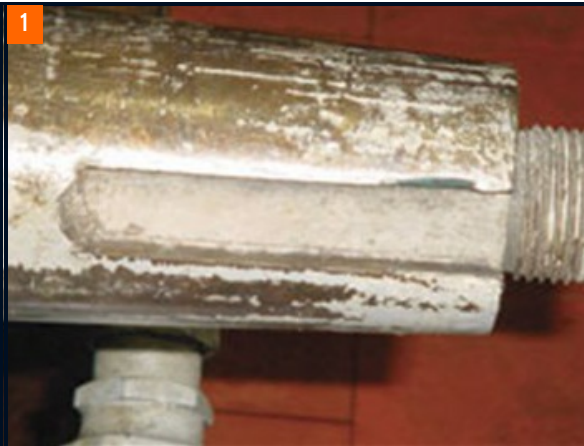
The tapered coupling and keyway were damaged on the main power input shaft.

1. The damaged shaft and keyway
2. Application of Belzona 1111 to the former
3. Former being clamped onto the shaft
4. Both ends of shaft rebuilt
