# BELZONA REPAIRS MASSIVE FAILURE OF KILN SUPPORT CASINGS

ID: 447

Rotary kiln used in cement production

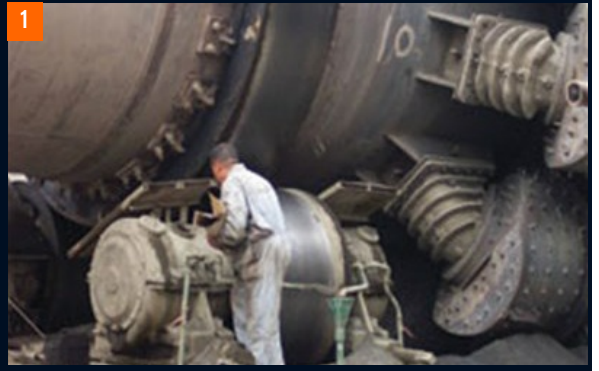
1. General view of the trunnion supports
2. The shattered casings
3. One of the fabricated strengthening plates in position
4. Belzona 1111 used to bond and seal the cracked casing

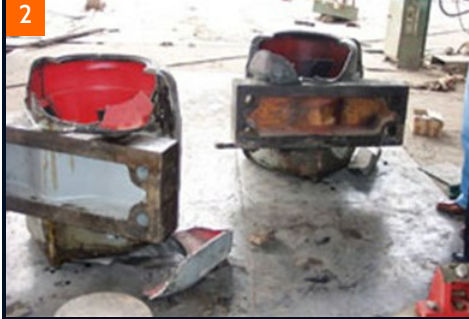
Casings on trunnion supports shattered due to the breakage of the roller neck.
