# BELZONA PROTECTION OF MAIN COOLING WATER PUMP

Multi-stage main cooling water pump for power station.

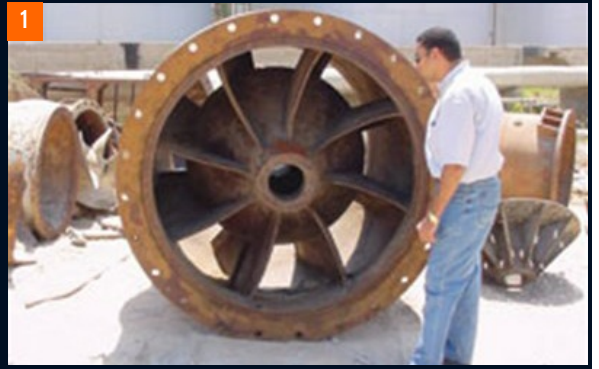
Severe erosion-corrosion caused by the brackish water being pumped.

1. Part of the pump being inspected
2. Rebuilding leading edges of vanes
3. & 4. various parts of the pump protected with Belzona 1341
