# BELZONA REBUILDS SOLE PLATES ON PAPER MACHINE

ID: 45

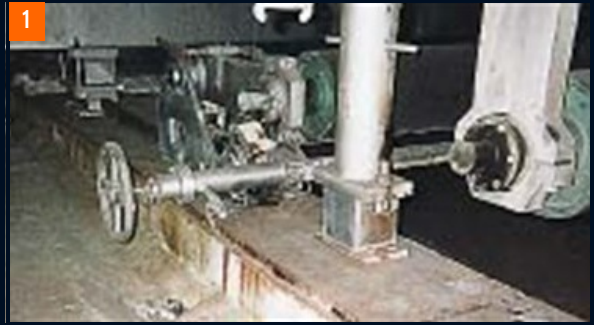
Corrosion of base plates would eventually cause the mill to bear the cost of structural steel replacements.

Base plates were subject to continuous white water attack and no coating had lasted longer than three months.

1. Cast iron sole plate alongside the paper machine
2. Surface prepared by pressure washing and grinding
3. Belzona 4111 (Magma-Quartz) being used to rebuild corroded sole plate
4. Finished application of sole plates
