# BELZONA EMERGENCY LEAK SEALING: THREE HOURS LATER - IT'S READY

ID: 450

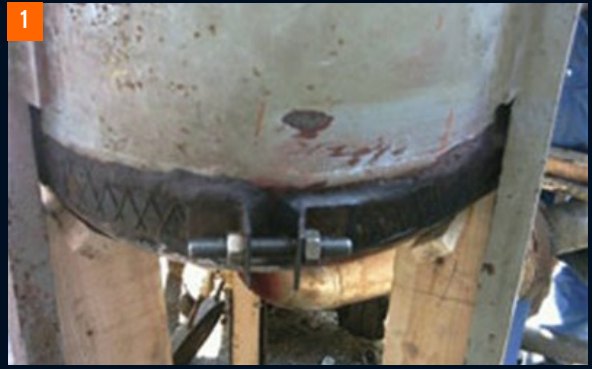
Corrosion of vessel had caused leak.

1. Belzona 1291 used in conjunction with metal clamp to initially stem the leak
2. Belzona 1111 plus Belzona 9341 (Reinforcement Tape) applied to strengthen the repair
3. Repair completed in 3 hours

Belzona® 1291 was initially used in conjunction with a metal clamp to stem the leak before applying Belzona® 1111 with Belzona® 9341 (Reinforcement Tape) to complete the application. Repair completed quickly and safely without heat so preventing the need for a major plant shut-down.
