# BELZONA PROTECTS GAS SEPARATOR FROM PITTING CORROSION

ID: 4505

Feed gas liquid separator

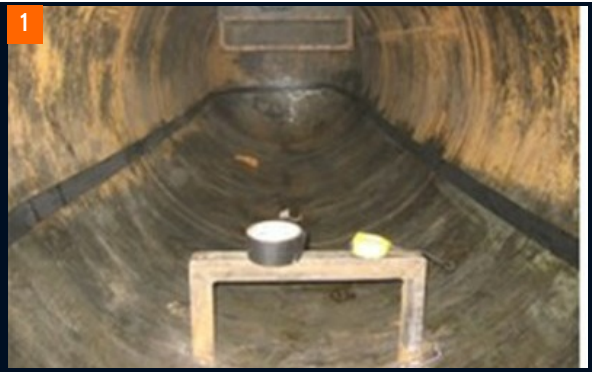
Severe pitting corrosion in the internal wall of the vessel due to presence of sour gas.

1. Internal wall of the vessel before application
2. Pitting corrosion in the wall
3. Completed application
4. Inspection after 6 years

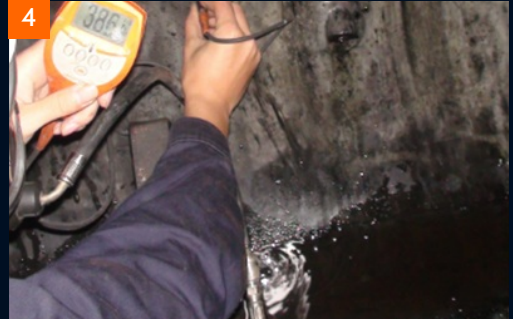
By using the Belzona solution, the corroded areas of the separator were repaired and protected from further corrosion. The vessel has been operated with H<sub>2</sub>S present for a further 6 years without defects being found.
