# REBUILDING TURBINE FLANGE FACES WITH BELZONA

ID: 451

Low pressure steam turbine

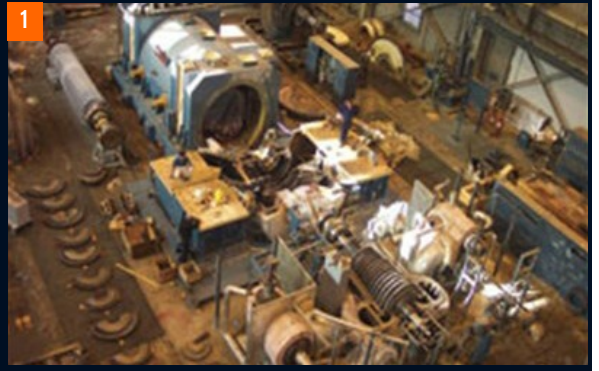
1. General view of the turbine
2. Typical damage found on the flanges
3. Former clamped in place to form the Belzona 1311
4. One of the many repaired areas

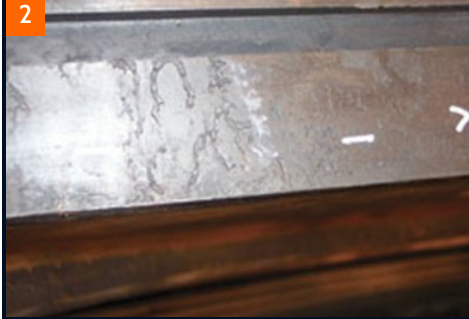
Corrosion and steam cutting on many areas of flange faces.
