# PROTECTION OF CHILLER WITH BELZONA CERAMIC METAL SYSTEM

ID: 452

Chiller unit from the hotel's air conditioning plant

Hotel complex in Egypt

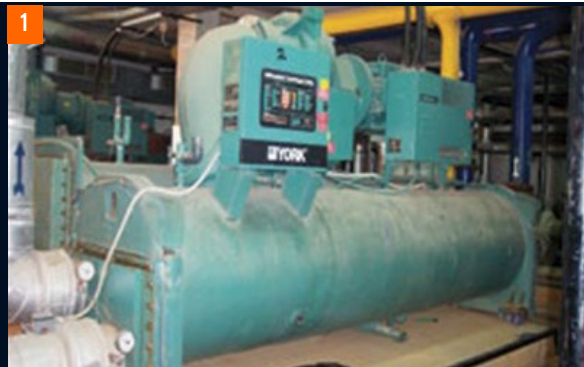
1. General view of the chiller
2. Degree of corrosion clearly evident
3. Corrosion pitting being rebuilt with Belzona 1311
4. Completed application after application of Belzona 1321

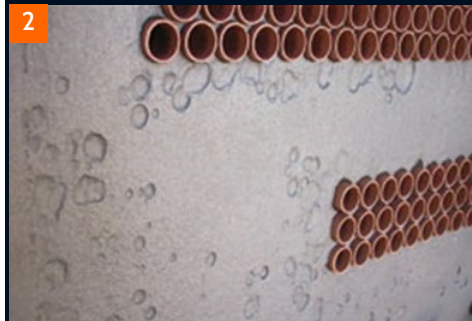
Corrosion of end covers, water box and tube sheet due to brackish water used for cooling.
