# BELZONA REPAIRS TO FERRY MAIN ENGINE

ID: 453

Severe cavitation and corrosion in cylinder block bores in way of cylinder liner lands.

Main diesel engine from ferry

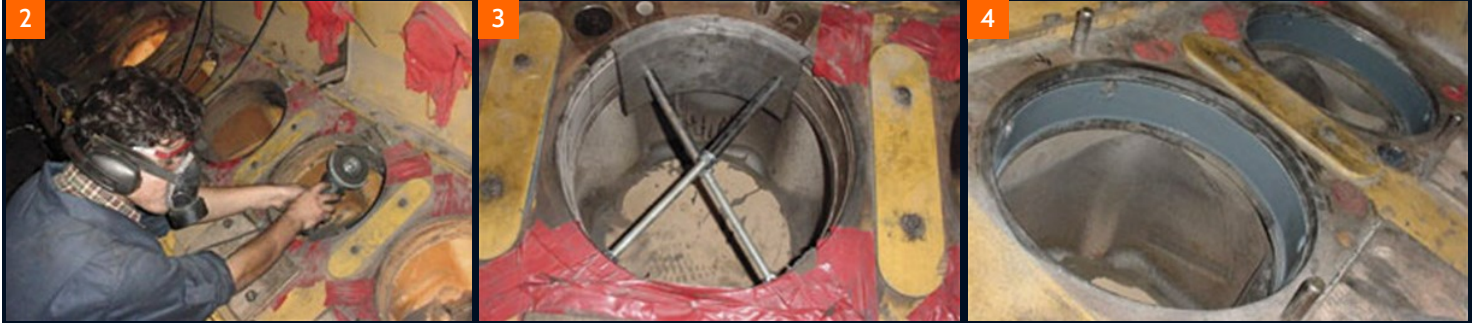
## PHOTOS

1. The severity of the cavitation clearly evident
2. Surface preparation underway
3. The Belzona 1311 being formed to profile
4. Completed application with Belzona 1391 applied to top water gallery

Application was carried out in accordance with Belzona Know-How System Leaflet ENC-6.

Belzona® 1311 used in conjunction with formers to rebuild cavitated areas and restore profiles. Belzona® 1391 applied to coolant galleries. This is a routine repair on engine blocks as cavitation is a common problem in this area of the engine. The Belzona provides a quick effective repair without heat and provides good cavitation and corrosion resistance in the hot coolant.
