# 'ISOLATION' PROBLEMS SOLVED WITH BELZONA

ID: 454

Isolation spools for titanium cooler

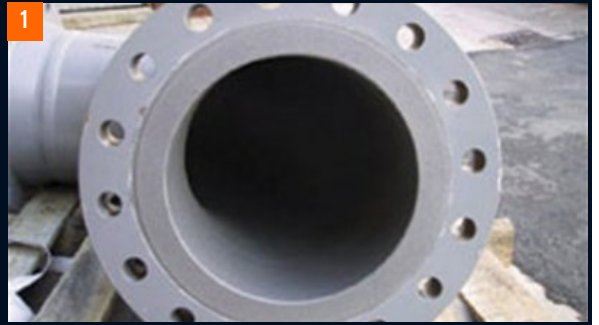
1. Pipespool grit blasted and ready for coating
2. Following coating and removal of the former ready for dressing
3. Post pressure test awaiting despatch to customer

Belzona® 1391 and Belzona® 1591 were applied to the internal surface of each of the spools in accordance with Belzona Know-How System Leaflet VPF-2. To eliminate the possibility of defects, which would allow very rapid corrosion, the coating materials were applied as two coat systems. Immediately following application of the second coat, the flange faces were reformed according to Belzona Know-How System Leaflet VPF-13.

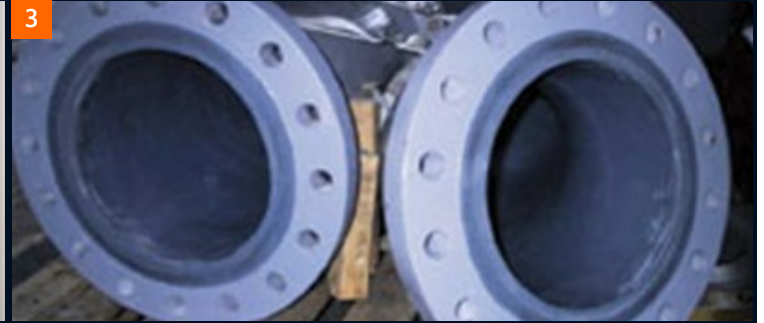
A total of four flange pipespools were coated and the flange faces reformed using this process. Subsequent inspection some 12 months later revealed the pipespools to be in perfect condition.
