# BELZONA FLANGE REPAIR SYSTEM ELIMINATES BLUSHES ON NEW PROCESS VESSEL

ID: 455

Nozzle flange faces on offshore process vessel due for urgent delivery

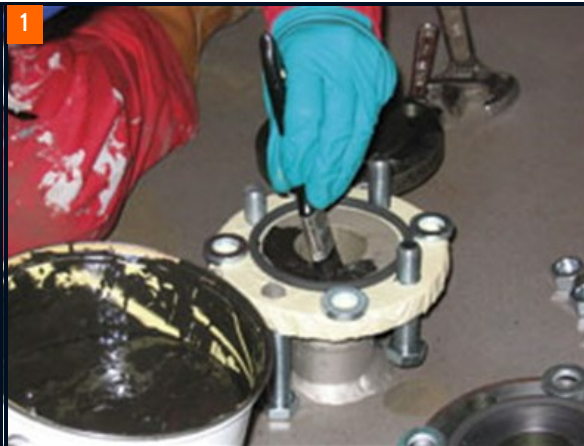
During surface preparation prior to the installation of a Belzona coating, grit blasting damage had occurred to four internal nozzle flange faces. As a result of this the sand recovery system due to be installed could not be fitted.

1. Application of Belzona 1591 to flange face
2. Completed assembly showing former, bolts and shim
3. Finished flange face awaiting removal of masking tape and dressing of internal bore

The flange faces were reblasted fully and Belzona® 1591 was installed using a forming process according to Belzona Know-How System Leaflet VPF-13.
