# BELZONA FLANGE REPAIR SYSTEM SAVES MONEY

ID: 456

Flange faces on 16", 300lb crude oil transfer hoses

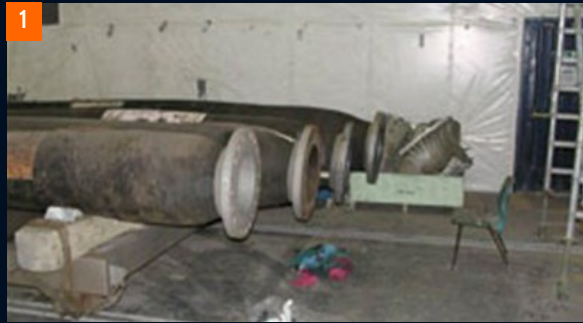
The four hoses shown in the picture represent a cost to the customer if replaced of approximately £100,000 (\$160,000). All four hoses were effectively covered and tested to 18 bar according to International (OCIMF 1991) and Dunlop Oil & Marine Test Guidelines. This was done for a fraction of the cost of replacement hoses.

1. Four floating hoses awaiting repair
2. Close up showing corrosion damage and plugs and shims fitted into place
3. Completed application, awaiting dressing down and pressure testing

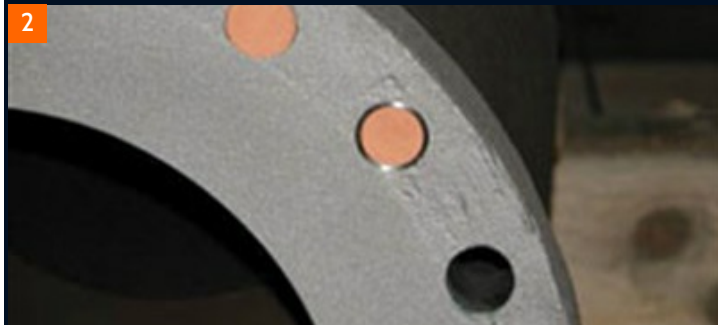
External corrosion on the flange faces had resulted in the hoses not being able to seal correctly and as a result were considered no longer fit for purpose.

A procedure based around Belzona Know-How System leaflet VPF-9 was used to reform the flange faces.
