# NOZZLE STABILISATION AT ONSHORE GAS PLANT

ID: 458

Corroded 2.5" nozzles on gas stabilisation vessel.

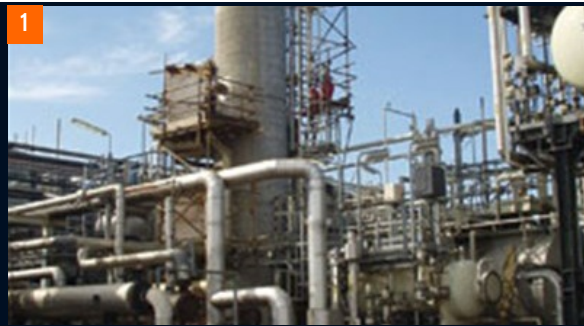
1. Gas stabilisation tower being sheeted ready for grit-blasting
2. CUI Corrosion damage to the neck of the nozzle
3. Completed application following injection of Belzona 1391 and application of Belzona 5111/6111
