# BELZONA PROVIDES PROTECTION FOR PRIMARY FAN PUMP

ID: 46

Primary fan pump suffering from erosion/corrosion.

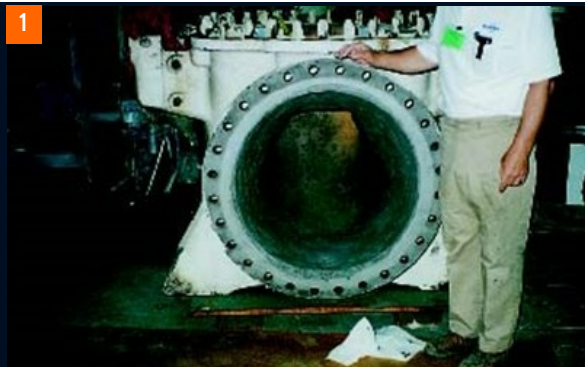
White water chemical attack of this large critical pump caused corrosion pitting of the cast iron pump case, as well as bi-metallic corrosion of the stuffing box.

1. Bottom section of the corroded fan pump
2. Final application of Belzona 1311 to pump case
3. Rebuilt fan pump with Belzona 1311 and Belzona 1341
