# WATERPROOFING CHIME ANGLE WITH BELZONA

ID: 460

Corrosion was occurring on steel/concrete interface of wastewater tank and pad.

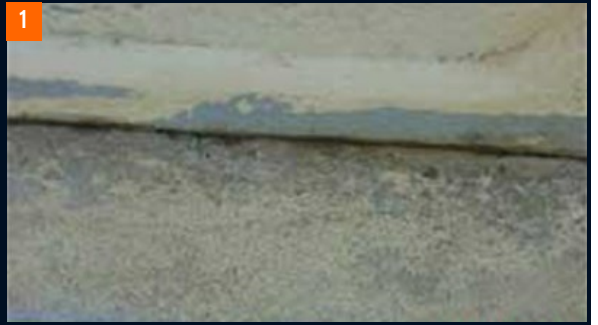
1. Close look at the problem area
2. Prepared surface taped off
3. Application completed
