# BELZONA SAVES CRITICAL EQUIPMENT AT ZINC MINE

ID: 4605

Raw ore mill at a zinc mine and refining facility

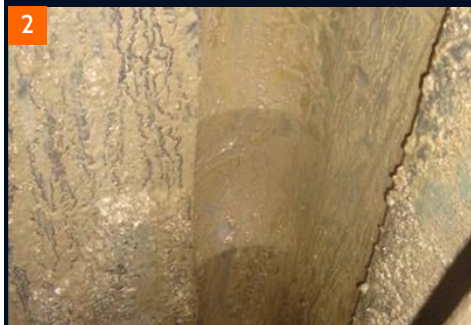
Wear on the riding ring of the primary ore mill resulted in the development of a hole. This allowed leakage of slurry into the mill gearbox lubrication system. As this was a single stream mill, this was a critical piece of equipment and needed to be returned to service immediately.

Aerial view of the Zinc mine Initial view of the damaged area Damaged area following cleaning Belzona 1111 repair 3 years later

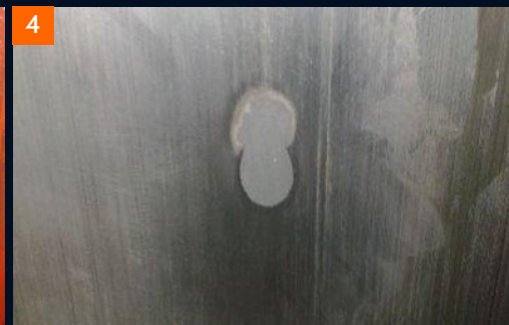
Belzona 1111 quickly sealed the leaking areas, preventing further contamination and allowed the critical part to return to service faster than conventional repair techniques, saving the customer in downtime and resulting production losses. After three years the repaired area was inspected and is still in perfect condition.

Belzona 1111 Super Metal was applied in accordance with a modified version of Belzona Know-How System Leaflet TCC-5
