# BELZONA PROTECTS COAL DIRECTOR

Coal director for pulverizer

Coal-fired Power Plant - Ontario, Canada

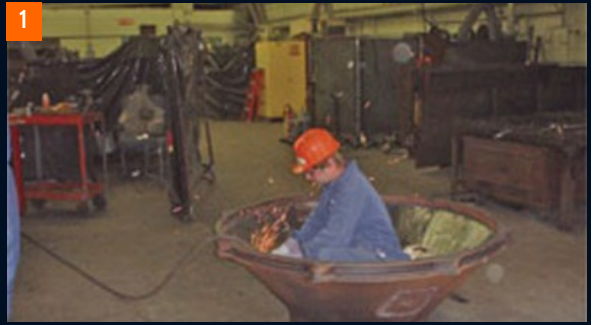
1. Surface preparation
2. Product was kept warm with the help of this steam pipe
3. Completed application

New steel was put in place. Steel was hand prepared and Belzona® 1812 material was put down with 1/8" thickness. This Belzona system provides excellent abrasion resistance, while ensuring the coal moves as required.
