# BELZONA REPAIRS AND PROTECTS QUENCH TOWER

Quench tower suffering Corrosion Under Insulation (CUI).

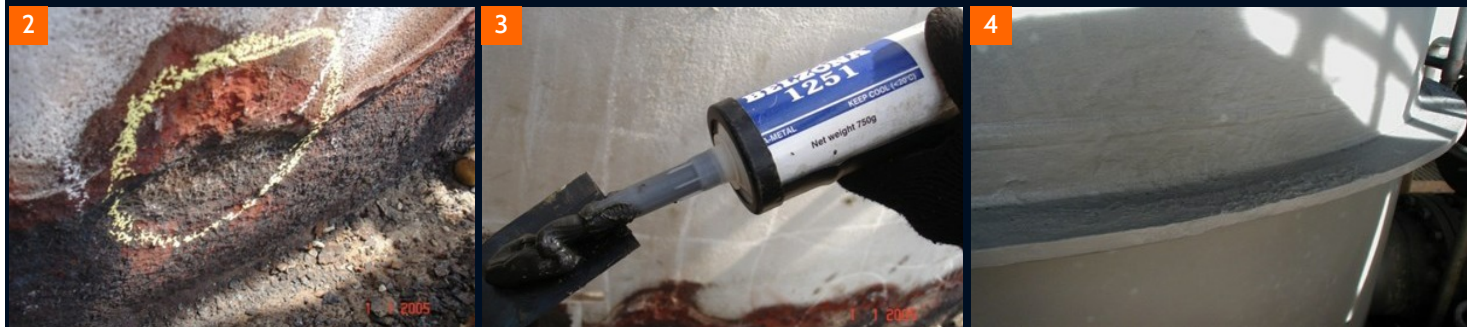
## PHOTOS

The tall carbon steel tower contains many trays and is insulated to prevent heat loss. Water penetration and condensation had led to severe CUI in many localised areas. The thickness of tower walls had reduced by more than 50% in some areas.

1. Surface condition behind insulation at 7m height
2. Severe damage due to CUI
3. Application of Belzona 1251
4. Completed rebuild with high temperature barrier coating Belzona 5851 applied to prevent further corrosion

Application was carried out in accordance with a modified Belzona Know-How System Leaflet TCC-5. Due to the hazardous area and live tower, scope of surface preparation was limited. Spark free tools were used to remove all loose corrosion back to a sound substrate. Belzona® 1251 was used to repair pitted areas, using doubler plates bonded over the most severely corroded areas. The tower was coated to prevent further corrosion using Belzona® 5851.
