# BELZONA SOLUTIONS FOR LEAKS

ID: 462

Filter drain - below grade.

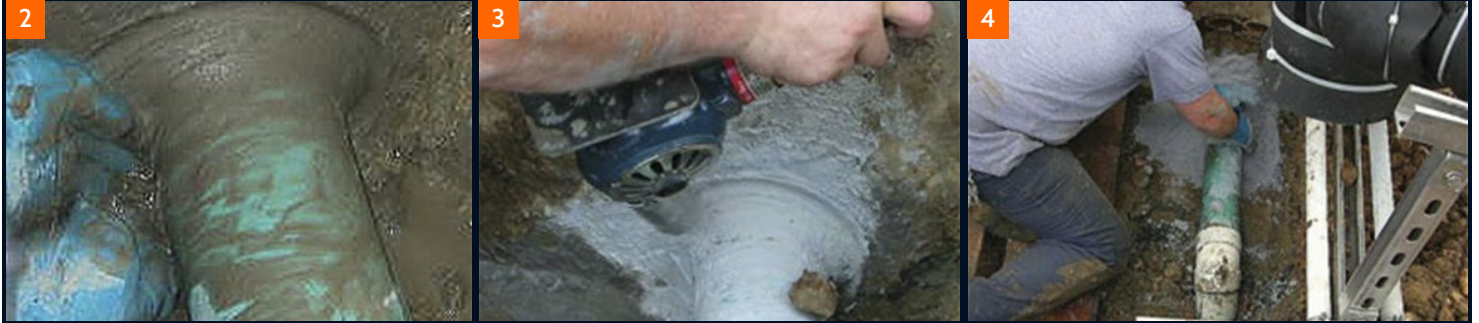
## PHOTOS

Filler used between the drain pipe and the wall when constructed was allowing water to seep through the one inch gap around the pipe and collect underground. A \$10,000 fine from environmental concerns was on the horizon.

1. Visible leak
2. Leak sealing with Belzona 4211 in process
3. External heat was applied to decrease curing time and ensure the area was dry
4. Finishing the application

The leak was stopped with Belzona® 4211, and then the area was dried with a hot air gun. Belzona® 4111 was used to seal off the leak permanently. This job was done outside during a heavy rainstorm.
