# BELZONA SEAL SOLUTIONS FOR GENERATORS

ID: 463

Generator housing

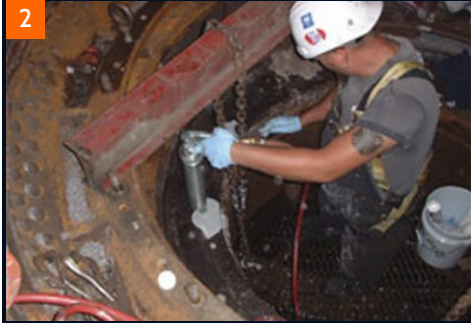
1. Traversing the St. Lawrence Seaway takes some 8.5 sailing days
2. Slurry mix of Belzona Systems being injected into the voids
3. Formers were fabricated to rebuild the inside seat area
4. Inside seat reformed

A slurry mix was made of Belzona® 4111 and Belzona® 4151 so it could be injected through the steel in concrete voids. Following this, Belzona® 1311 was used to provide an even seat for the generator to set upon.
