# BELZONA SEALS LEAKING MUSIC ROOM ROOF

ID: 4630

Roof over the music room at a prestigious private school

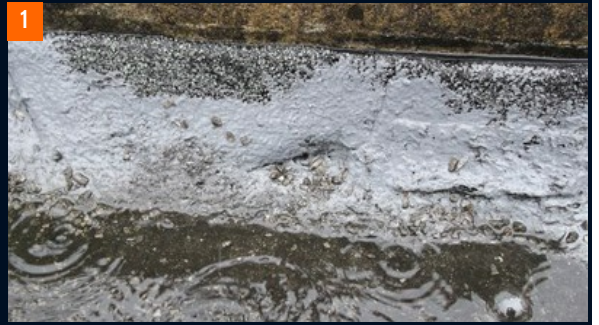
Breakdown of the old bituminous substrate had allowed multiple areas of water ingress causing damage to the fabric of the building & creating health and safety issues. Due to its location adjoining a listed school building a hot applied system was not acceptable.

1. Close up of previous repairs which had failed
2. Preparation of the roof by removing loose chippings
3. First coat of Belzona 3131 being applied with reinforcement sheet
4. Completed application several months later
