# BELZONA SEALS AND PROTECTS TRANSFORMER FINS

ID: 4638

Cooling fins on a 33Kv transformer.

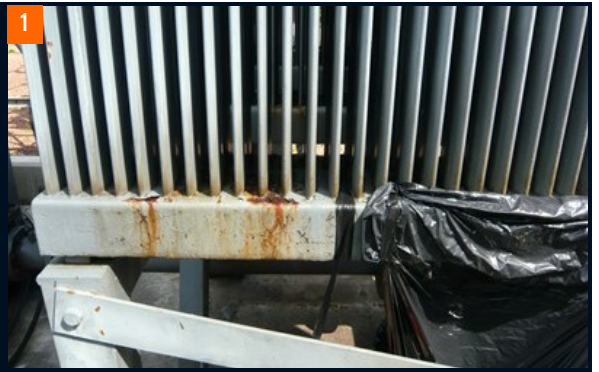
Over the years, corrosion had caused loss of wall thickness at the base of the transformer fins with leaks beginning to occur.

1. Fins before preparation
2. Plates being bonded to side and bottoms of the fins
3. Completed pour using Belzona 5831
4. Finished Application

The application was carried out in accordance with Belzona Know-How System Leaflet VPF-11a. The cooling fins were pressure cleaned and prepared where possible with an MBX Bristle Blaster. Live leaks were stemmed with Belzona 1291 and Belzona 1221. The fins were encapsulated using a 3mm metal plate bonded with Belzona 1161. Belzona 5831 was poured in to seal and encapsulate all the fins and then finally used to coat the fins.
