# BELZONA MAKES FOOTBRIDGE SAFE

ID: 464

Footbridge linking multi-story car park to shopping centre

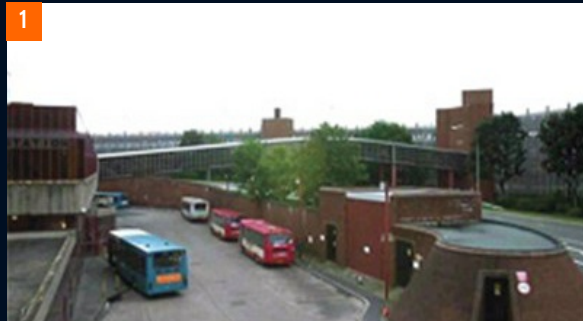
The enclosed footbridge suffered condensation which made the existing rubber floor covering very slippery.

1. Outside view of the footbridge
2. Surface preparation in process
3. Belzona 5231 applied
4. Application ready for traffic
