# BELZONA RESTORES WORN ARCHIMEDES SCREW

ID: 4643

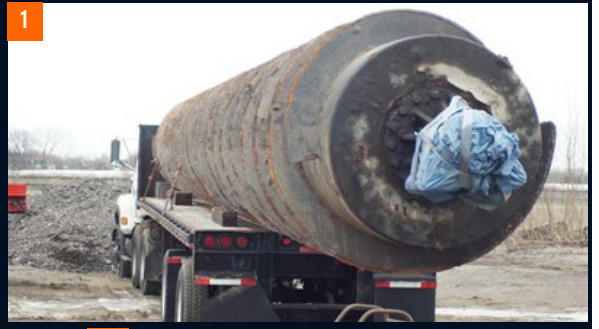
Erosion and corrosion caused the edges of the 58 inch long archimedes screw flights to be worn down, thus losing efficiency at Wastewater Treatment Plant.

1. Overview of 58 inch archimedes screw
2. Worn flights on flatbed hauler
3. Archimedes screw blasted and prepared for application
4. Belzona 1811 applied to the screw flights
