# BELZONA REPAIRS WASTE WATER SLUDGE TANKS

ID: 4647

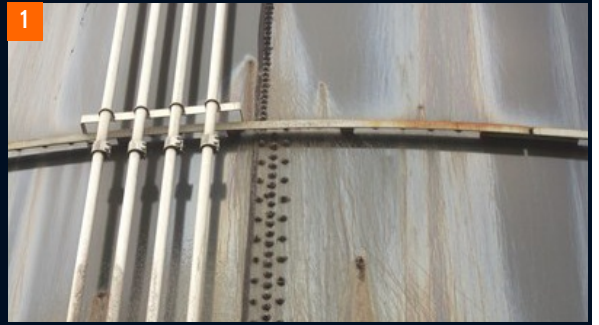
All three tanks were suffering from through wall corrosion at the vapour interface level. The tanks could not be taken off line due to demand and any repairs would have to be carried out without hot works or the use mechanical equipment due to the risk of sparks.

1. Original tank condition.
2. Plate bonding be carried out with Belzona 1161 from cherry picker no scaffolding was required.
3. Final coating with Belzona 5831
4. Area of finished repairs.
