# KITCHEN SAFETY IMPROVED THANKS TO BELZONA

ID: 465

Floors in kitchen area

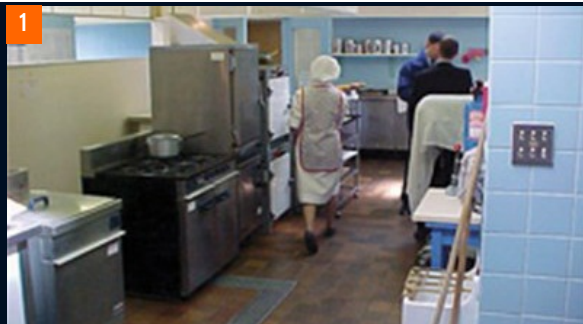
Routine health inspection had highlighted hygiene and safety problems with the floor area necessitating refurbishment before the school re-opened.

1. Kitchen area prior to the Belzona application
2. Wash area prior to the Belzona application
3. Belzona 5231 applied
4. Application completed

Two coats of Belzona® 5231 were applied after thoroughly cleaning and grit blasting the existing tiled surface.
